NWL TECHNICAL REPORT TR-2943  
January 1973

SURVIVABILITY OF AIR LAUNCHED GUIDED WEAPONS IN A FIRE ENVIRONMENT

#### ABSTRACT

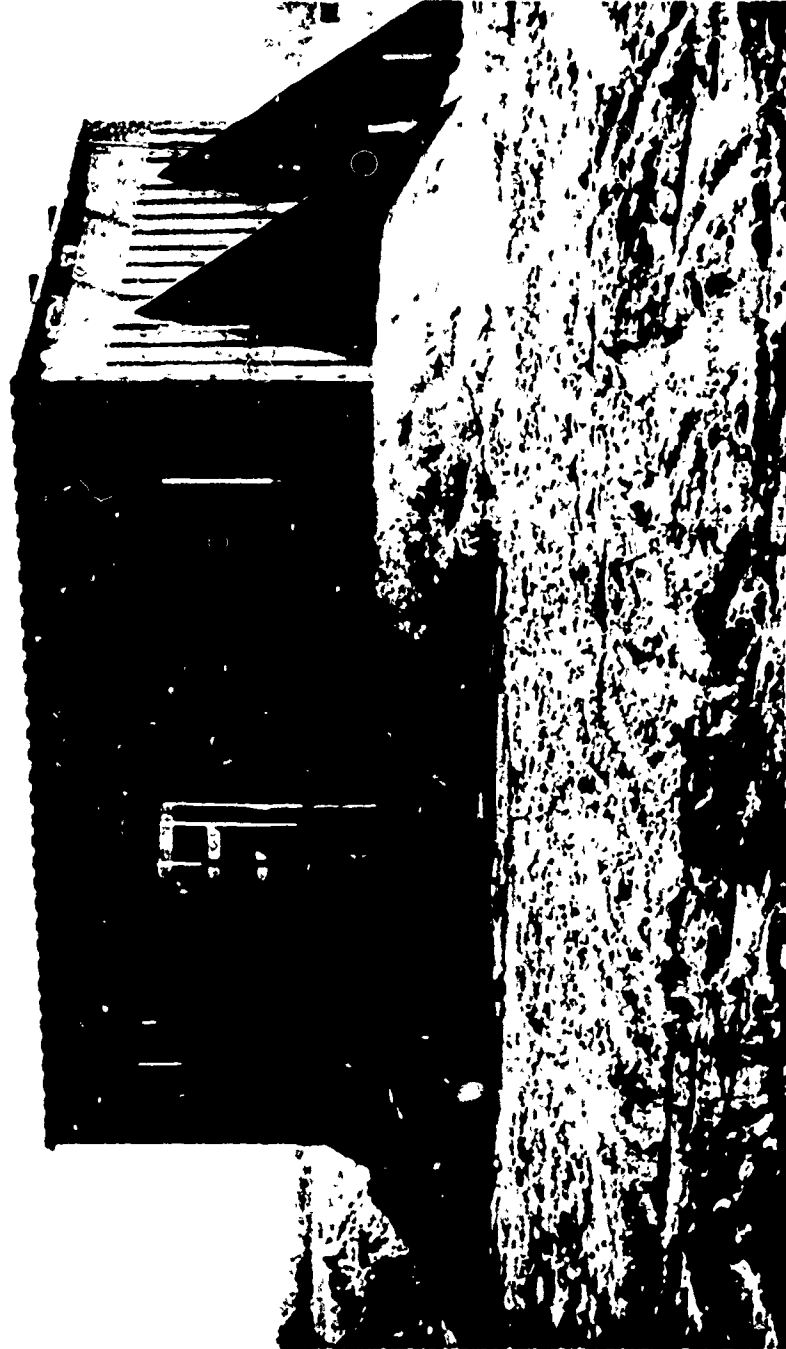
Figure 1 is an overall view of the retainer cage. It was used to prevent missile fly-away in the event of a design mode reaction. The cage had a 30-foot square base and encaged a 20-foot square test pit. Figure 2 shows the stand used to restrain the missiles during tests.

Fast cook-off test retainer cage used to test the guided missiles.

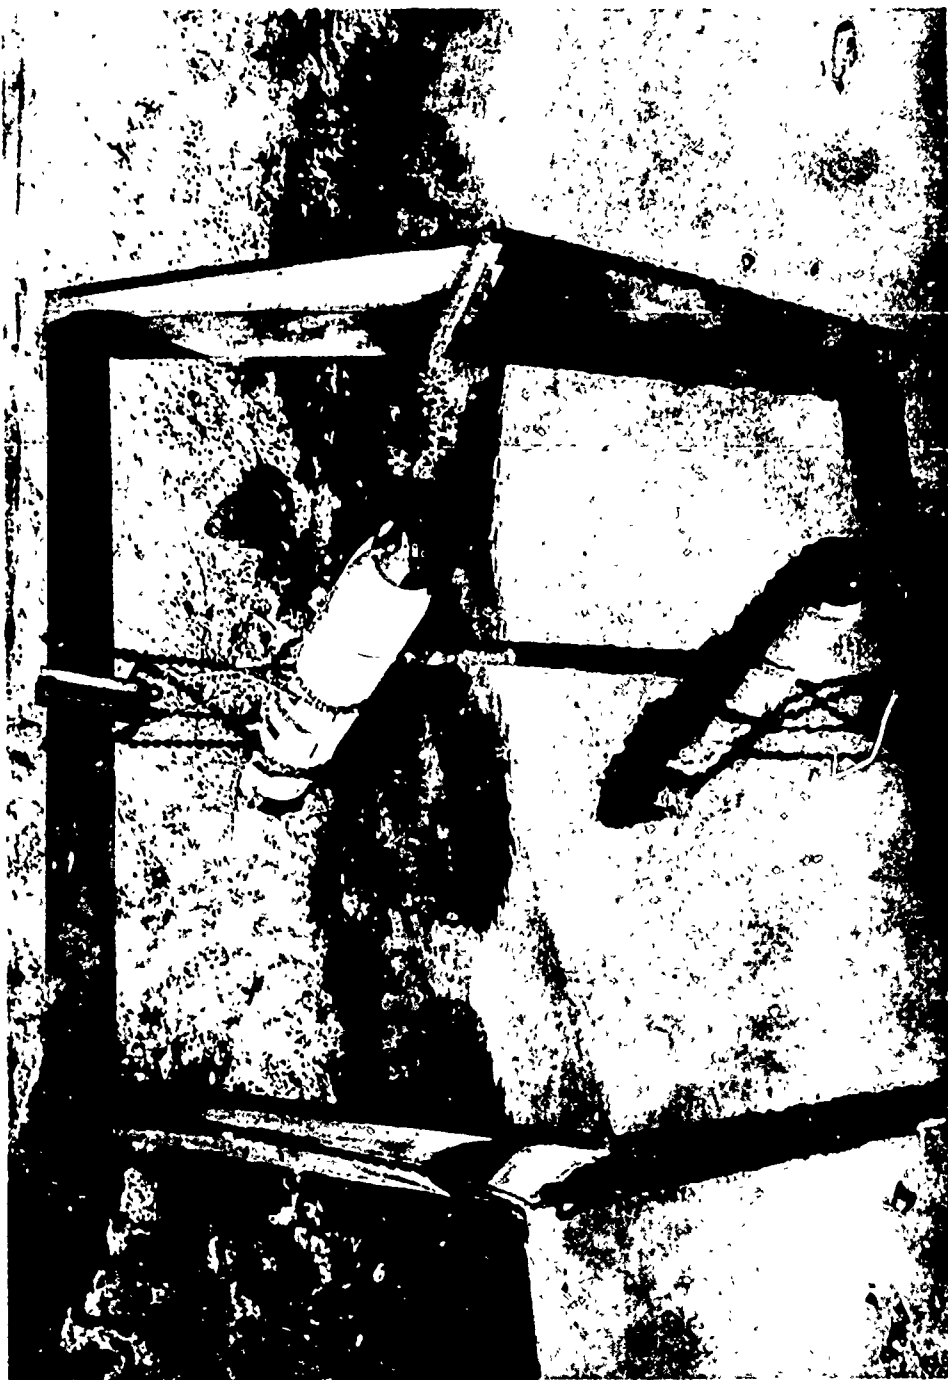
Figure 3 is a view of the open pit. It was used to test the WALLEYE guided weapons which are not designed to react propulsively. The walls of the pit were banked to a height of approximately eight feet, and the pit contained a 30-foot square burning surface.

Open pit used for fast cook-off tests of the WALLEYE guided weapons.

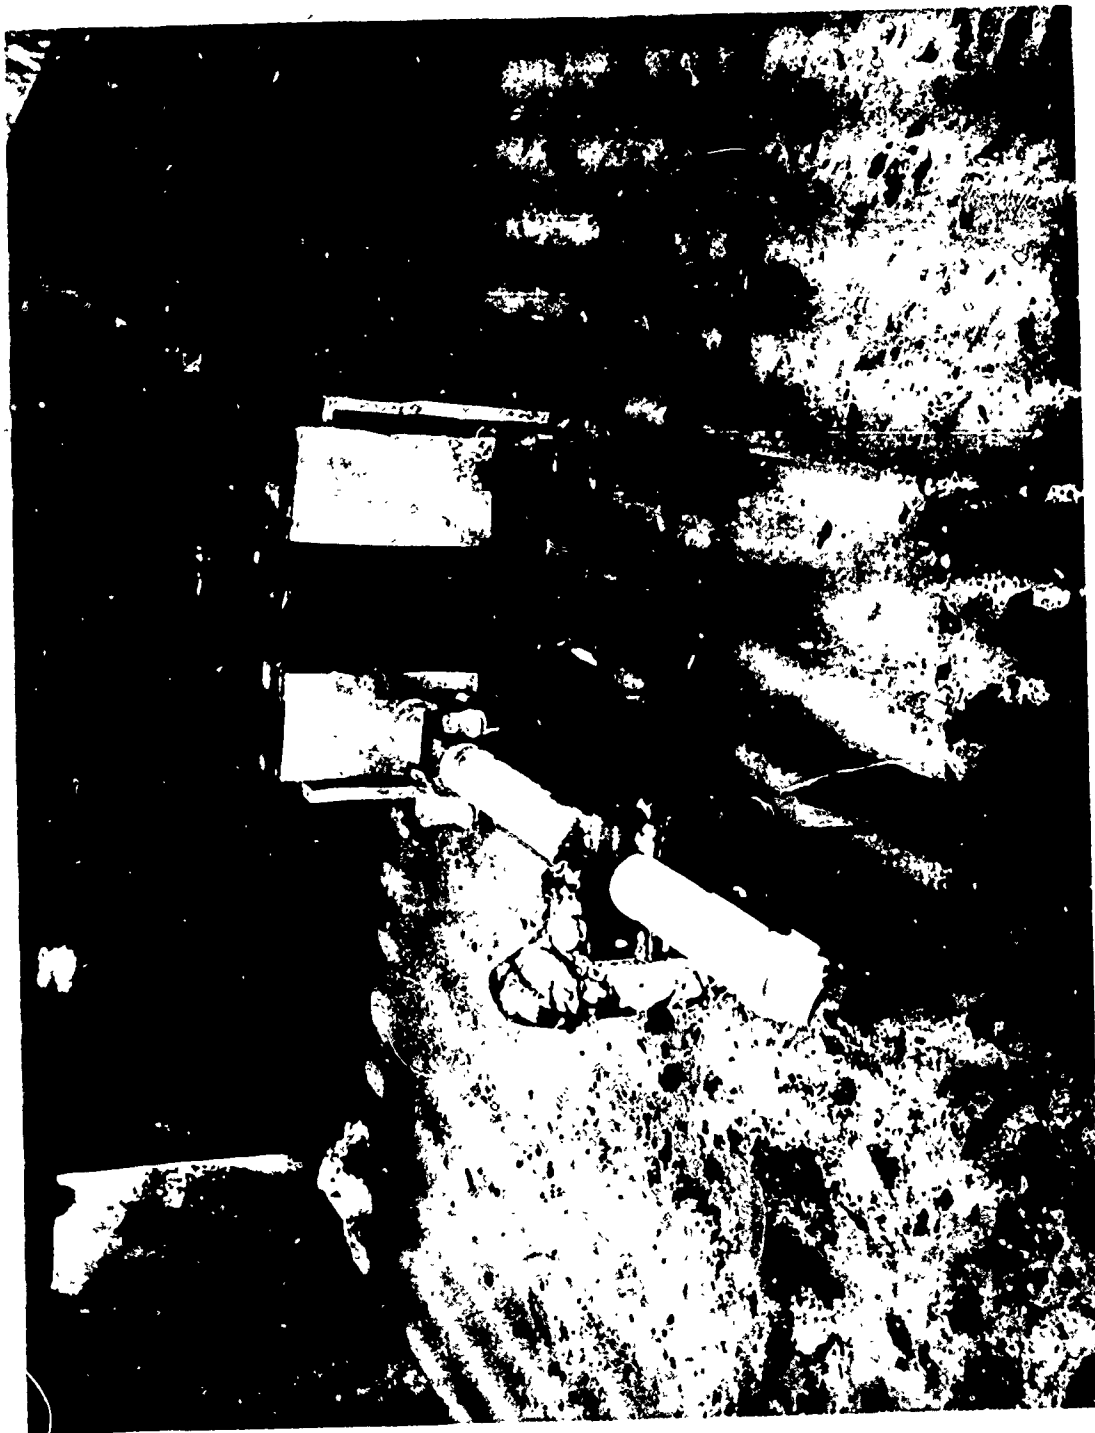
Figure 6

SIDEWINDER AIM-9 Missile after fast cook-off test No. GM-1.

View: Indentation on the retainer stand caused by the missile being forced forward by motor re-  
action.

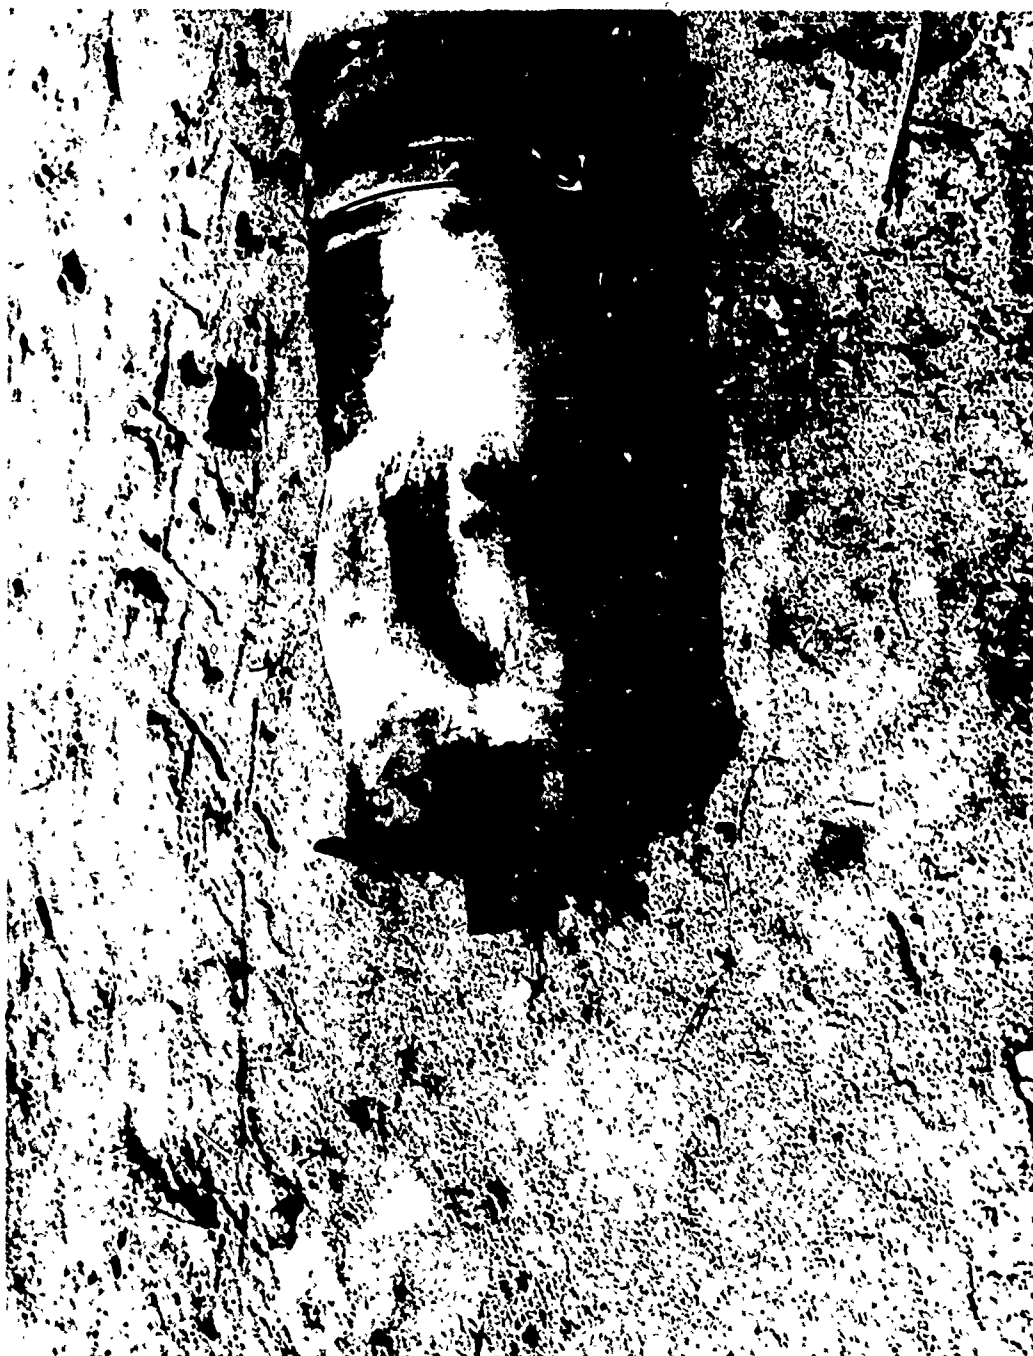
Figure 7

MARK 48 MOD 4 SIDEWINDER warhead after deflagration in fast cook-off test No. GM-1.

View: Bulge in warhead case.

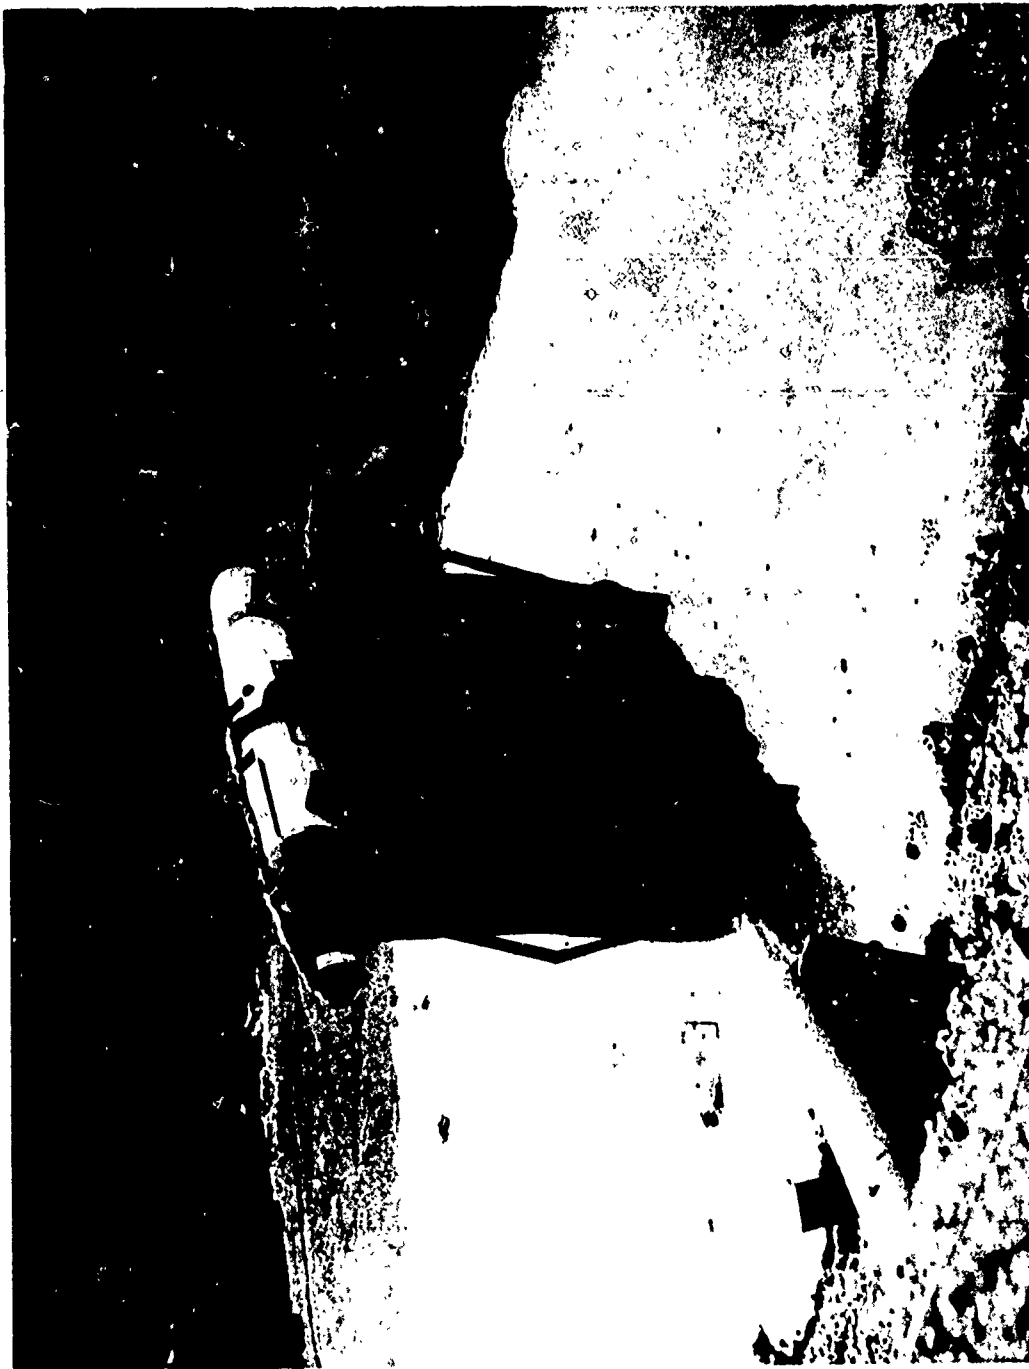
Facility: 30' x 30' open pit with test stand, Figure 9

WALLEYE Guided Weapon MARK 1 MOD 0 pre-test configuration.

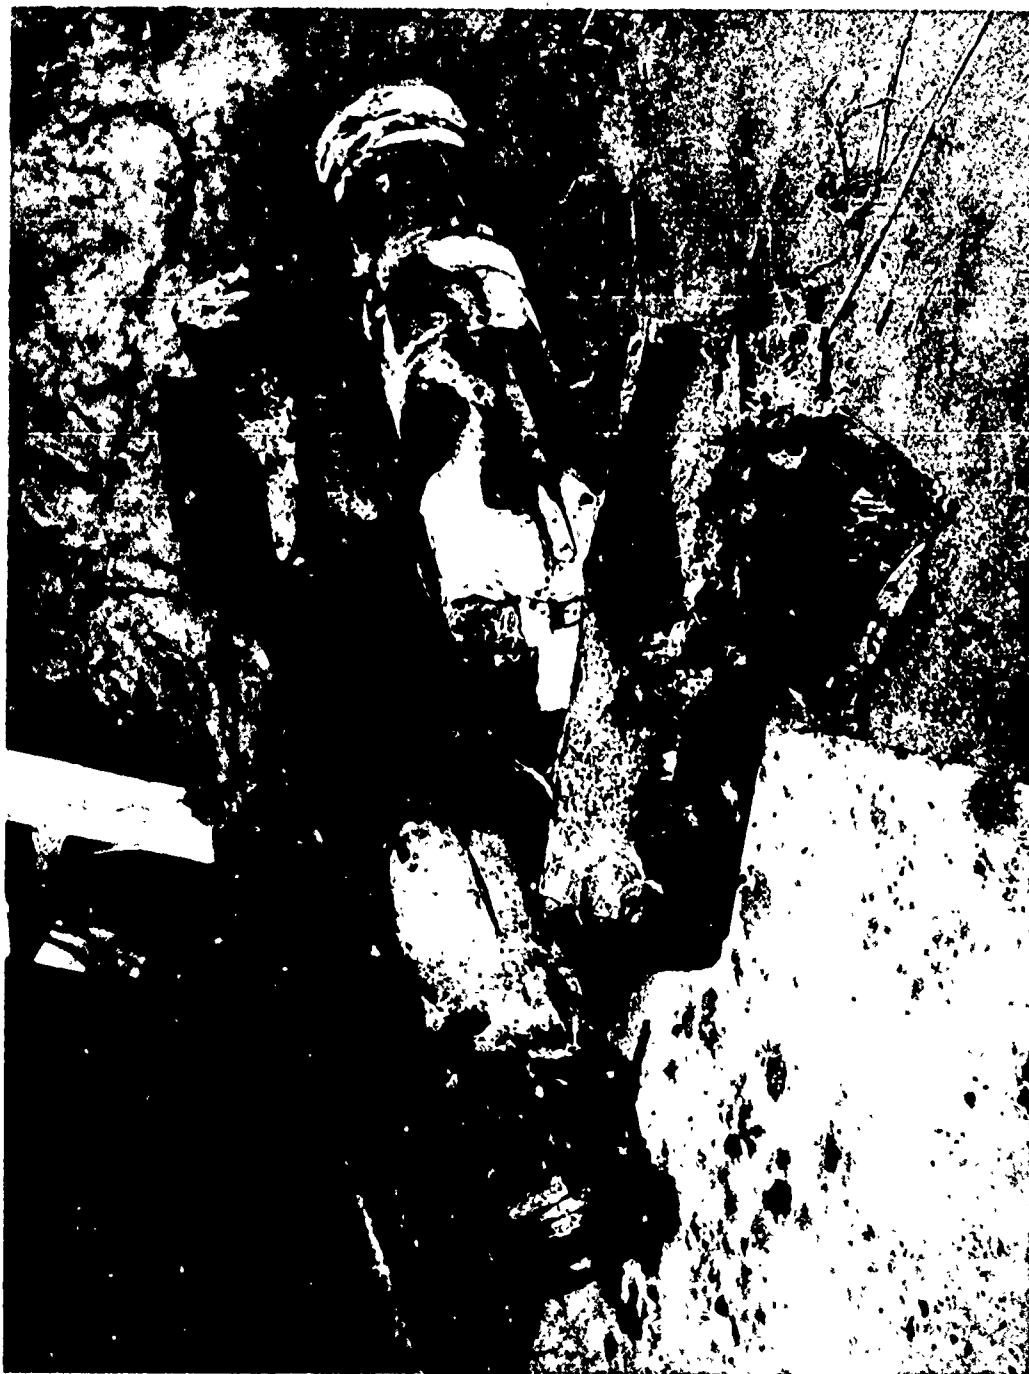
Figure 12

Results: At two minutes 3 seconds after fire ignition, the motor started to burn violently. The warhead reacted by burning at 16 minutes three seconds into the test. At four minutes 51 seconds after the warhead began burning, the safe and arm device deflagrated mildly. At one minute 13 seconds after the safe and arm device reacted, the booster deflagrated. Figures 11-13 show the pre-test configuration and post-test views of the weapon remains.

Remains of the SPARROW III AIM-7 Missile after reacting in fast cook-off test No. GM-5.

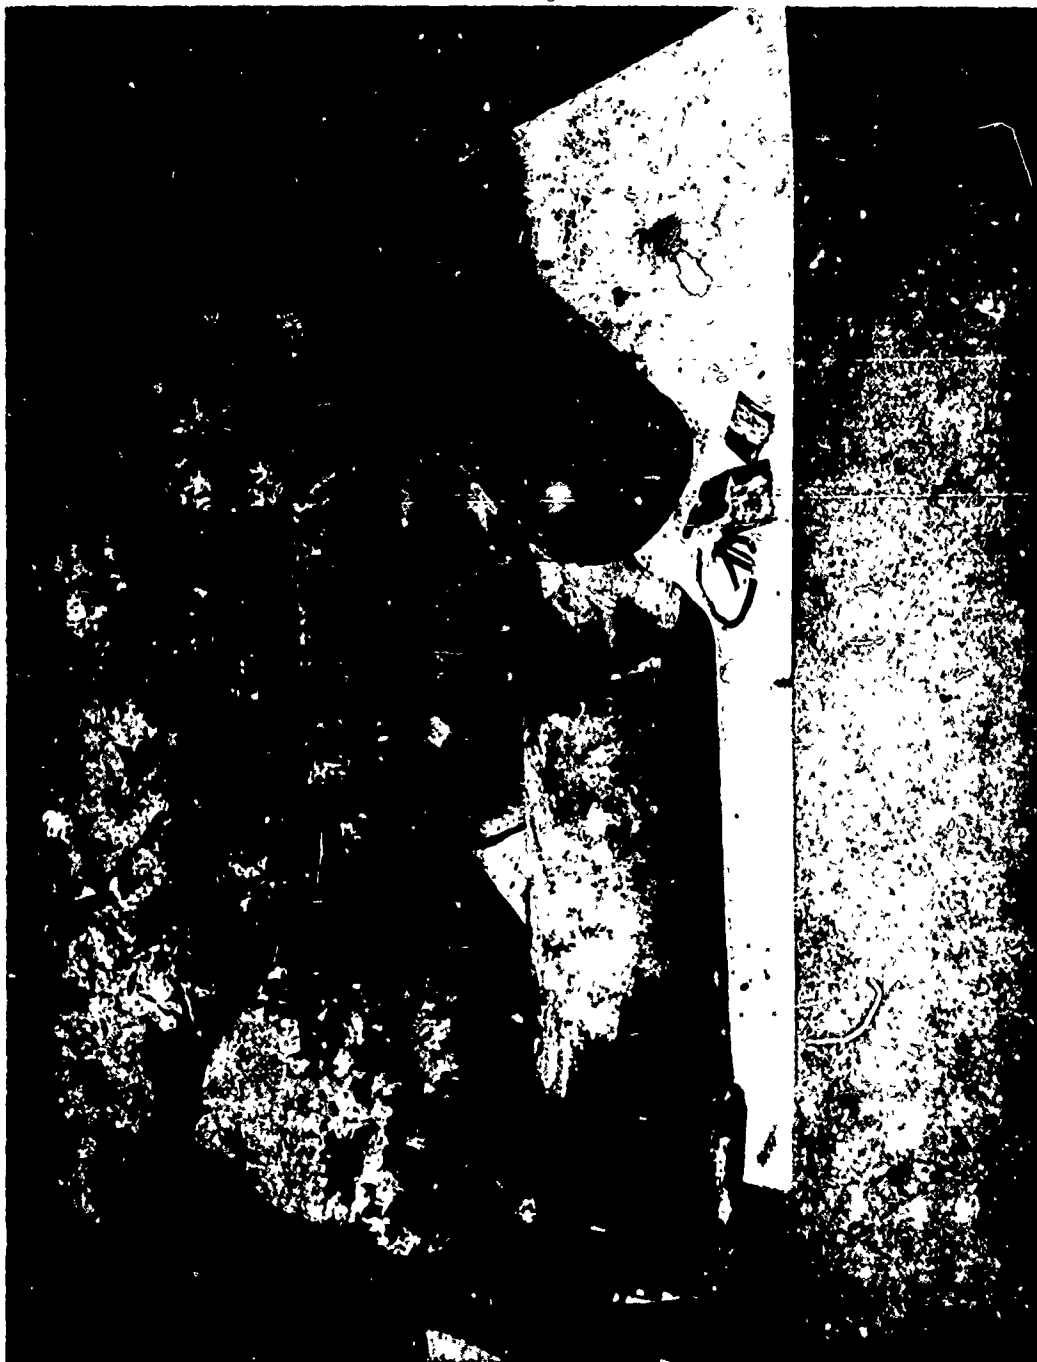
Results: The rocket motor deflagrated at one minute 31 seconds after start of fire. At fourteen minutes 10 seconds after the initial reaction, the warhead detonated. Figure 16 shows a sample of the fragments and pieces of the motor recovered after the test.

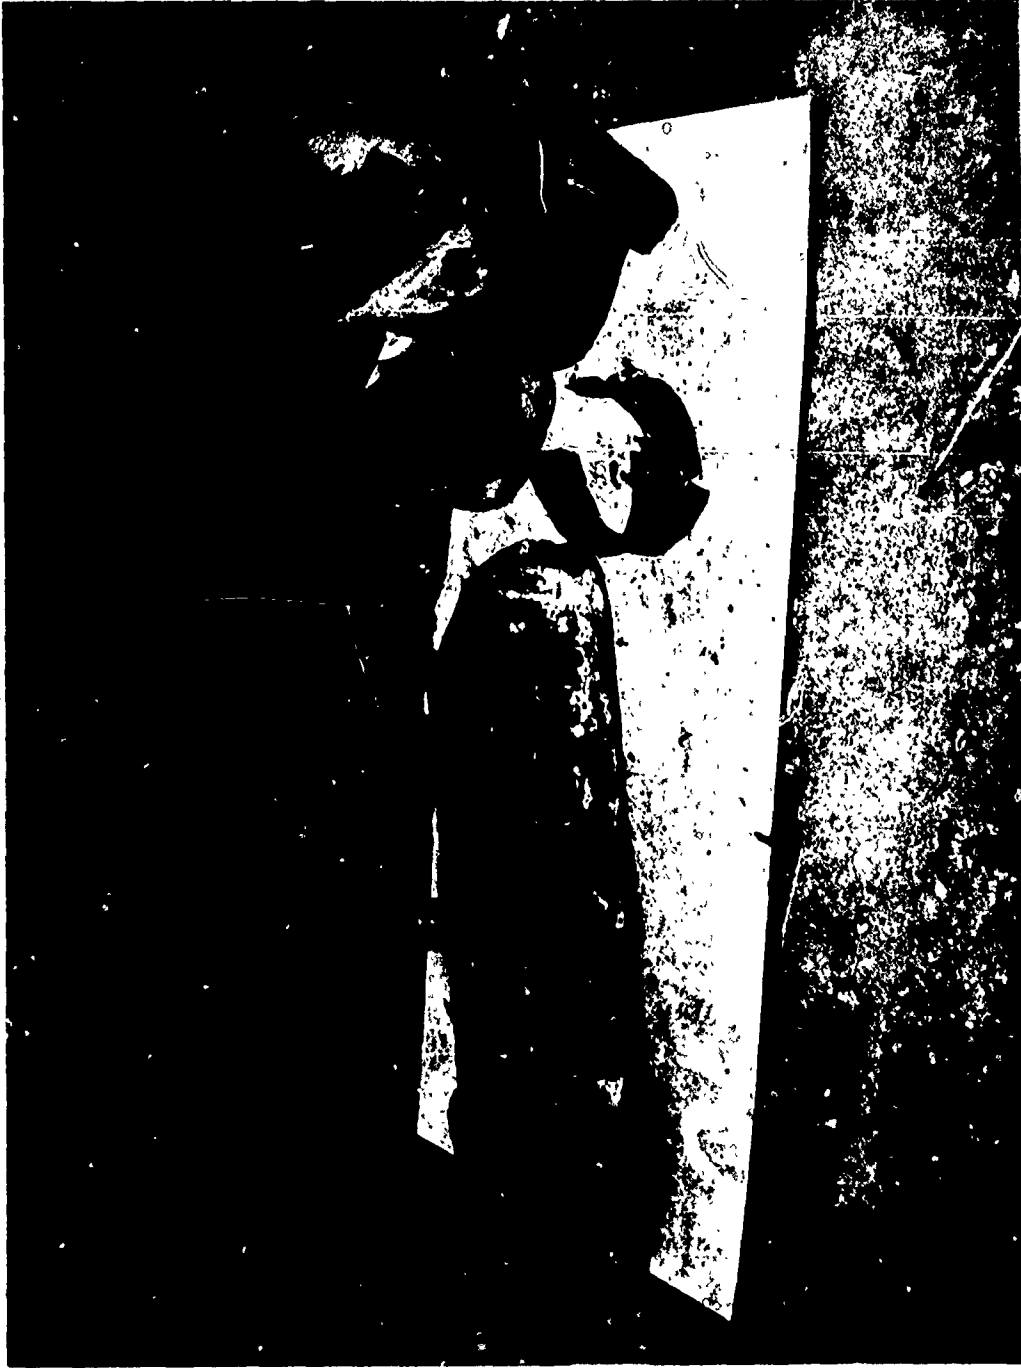
Figure 18

Results: At one minute 44 seconds after fire ignition,  
the rocket motor deflagrated. The warhead  
exploded at 13 seconds after the motor reacted,  
throwing fragments and burning explosive  
about the cage. Figure 17 shows the pre-test  
configuration. Figures 18 and 19 show the  
motor and warhead remains. Thermocouple  
locations are shown in Figure 20 and the time-  
temperature data are provided in Figure 21.

Pieces of the SHRIKE AGM-45A Missile motor after deflagrating in fast cook-off test No. GM-7.

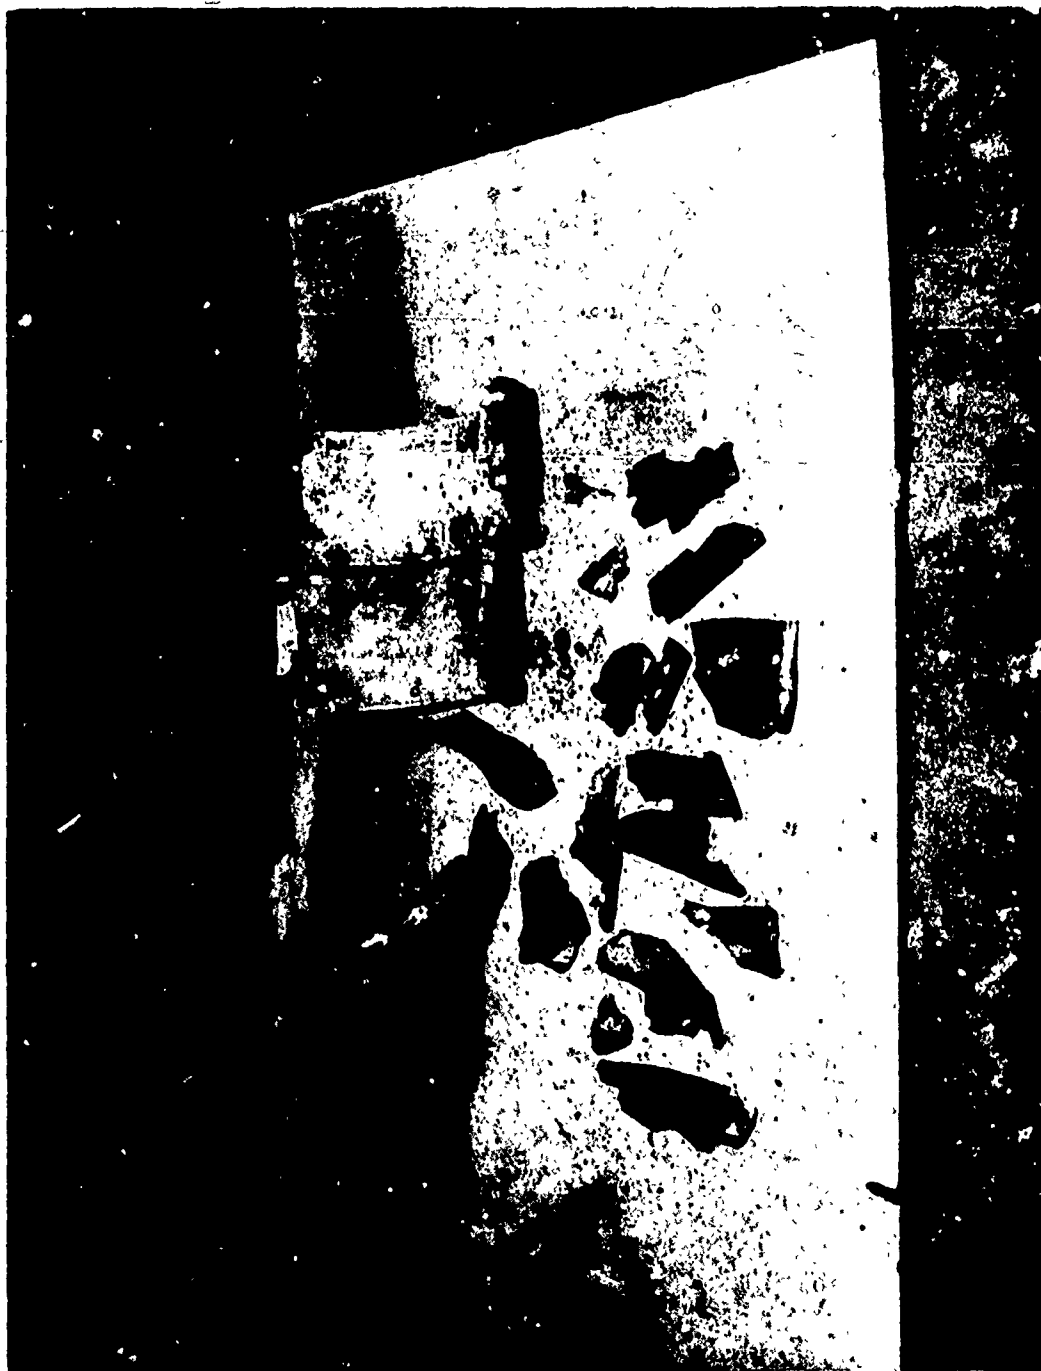
Figure 19

Fragments from SHRIKE AGM-45A Missile warhead and simulated guidance unit after exploding in fast cook-off test No. GM-7.

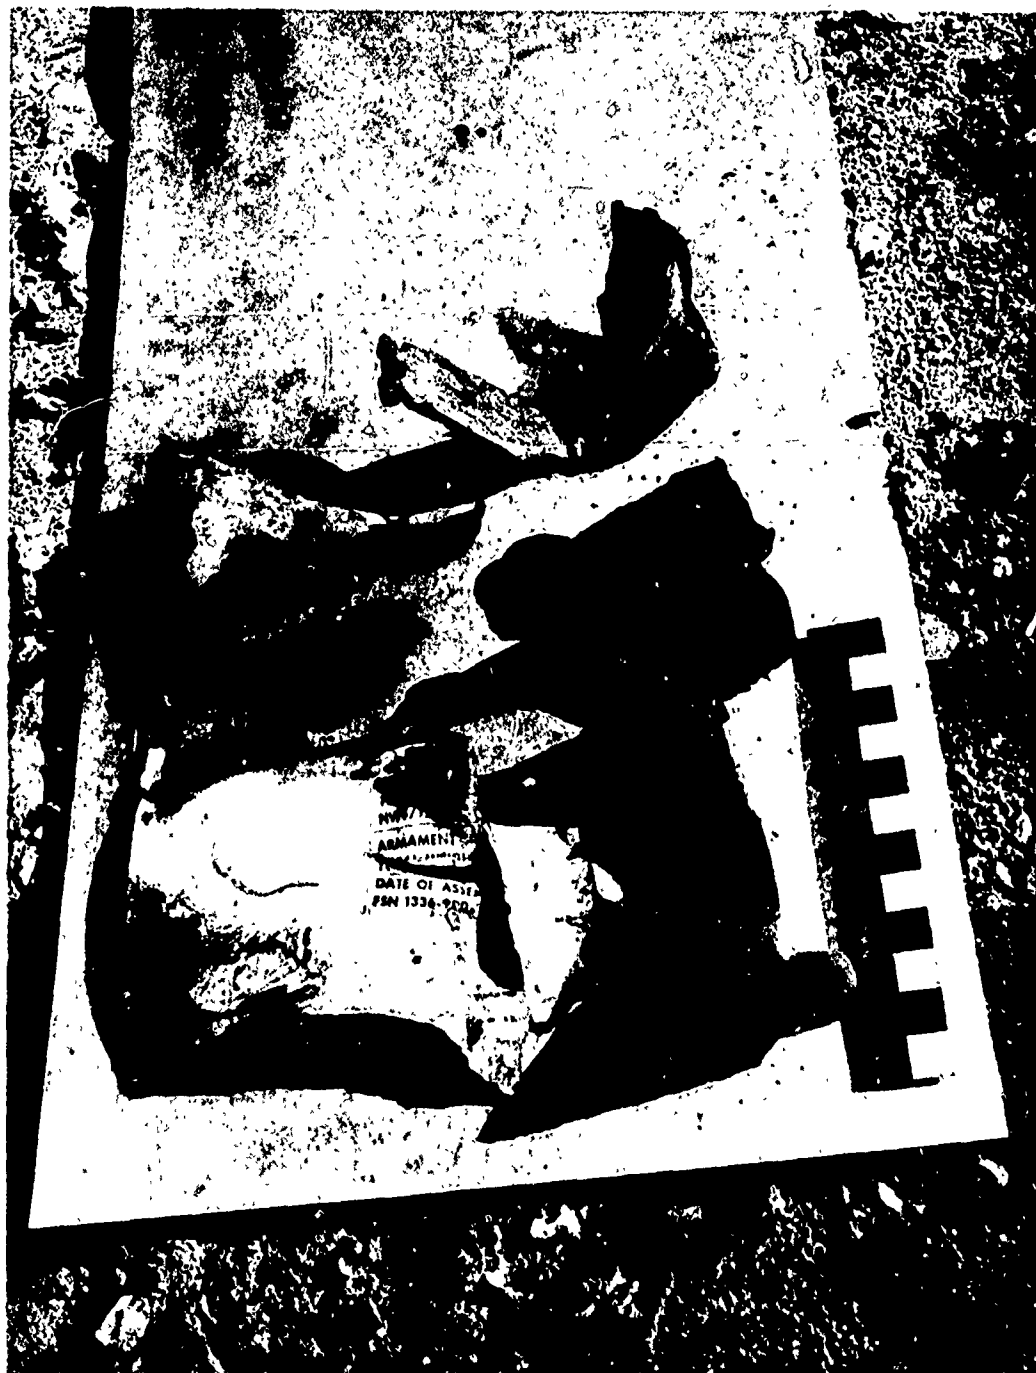
Results: The warhead exploded at one minute 17 seconds after the fire was started. The motor deflagrated at one minute 29 seconds. Fragments from the warhead were thrown about the test site. Figure 22 shows the warhead fragments that were recovered from the test. The remains from the motor are shown in Figure 23. Thermocouple locations and the time-temperature data are provided in Figures 24 and 25.

Fragments of the SHRIKE AGM-45A Missile warhead after it exploded during fast cook-off test No. GM-8.
